Wind Lake

Water Control Structure Examination Report

October 2015

Project No.: 2015-0014.01

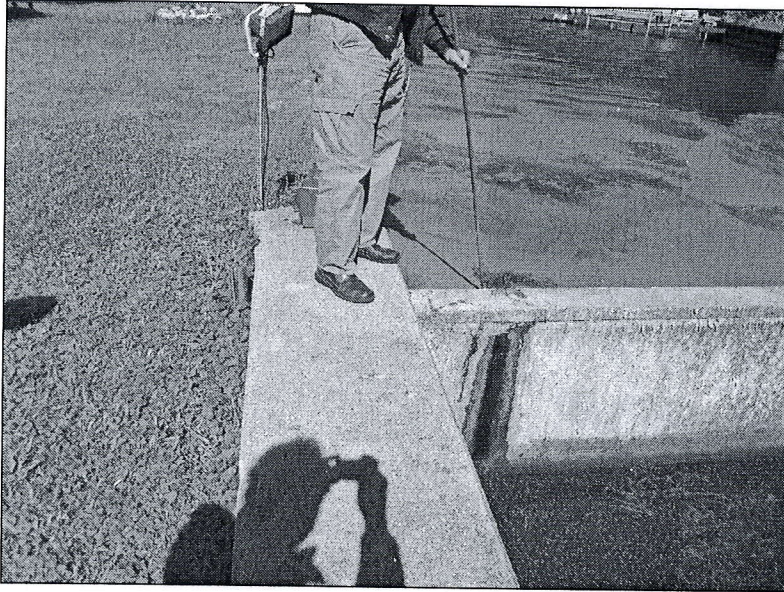
10040930201508

Condition #1 Fixed Crest Water Leak

Observations: Deteriorated concrete below steel channel cap leaks

Leak at fixed crest

Repairs: Prepare concrete surface when water levels are down and patch using concrete repair mortar.
Schedule: Repair within one year.

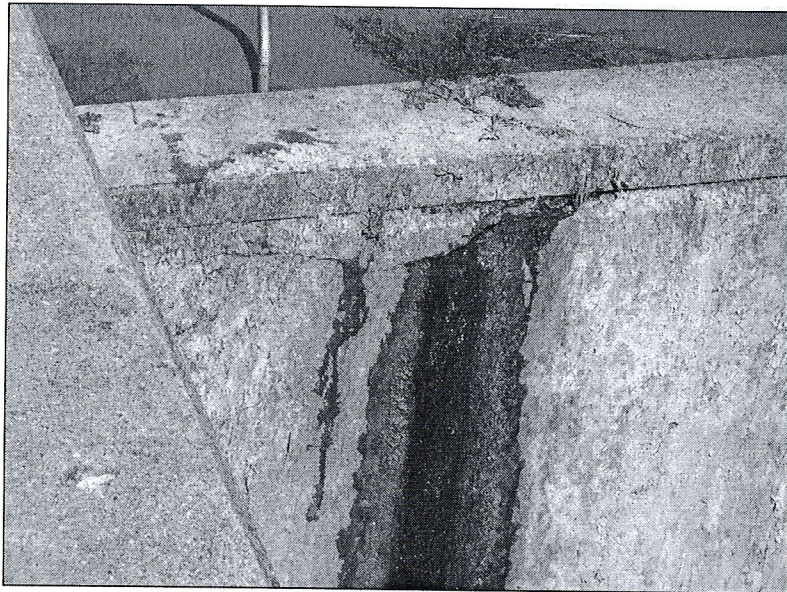
10040930201509

Leak at fixed crest

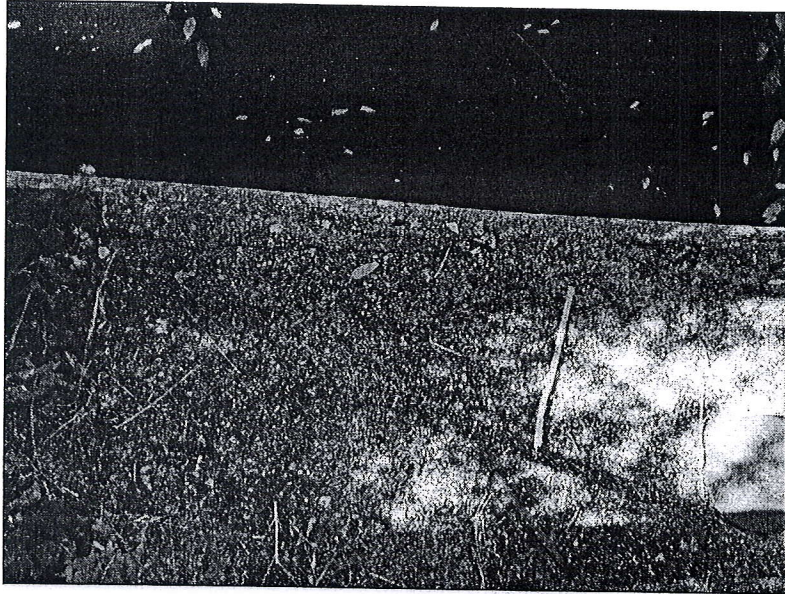
10040930201510

Condition #2 Minor Concrete Deterioration

Observations: Cracks in concrete. No loose concrete

Concrete cracks – Future spalls

Repairs Prepare concrete surface and patch using concrete repair mortar when spalls appear.
Schedule: Monitor.

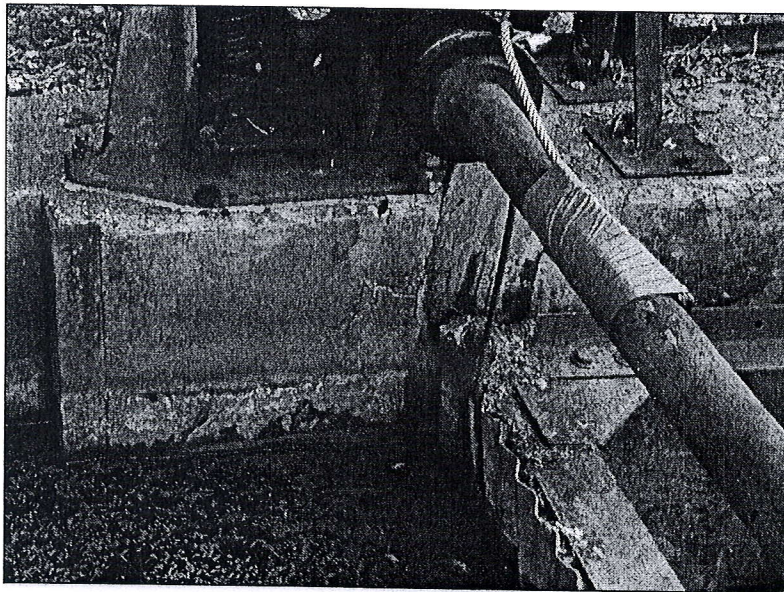
10040930201511

Concrete cracks – Future spalls

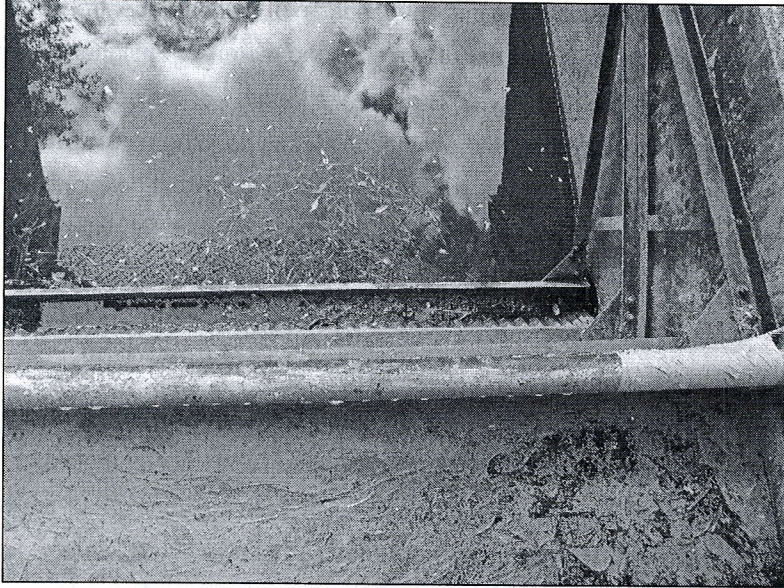
10040930201512

Condition #3 Gate Seal Leaks

Observations: Deteriorated concrete below steel channel cap leaks

Leak at fixed crest

Repairs: Determine gate to base dimensional variations. Readjust or replace seal.

Schedule: Monitor

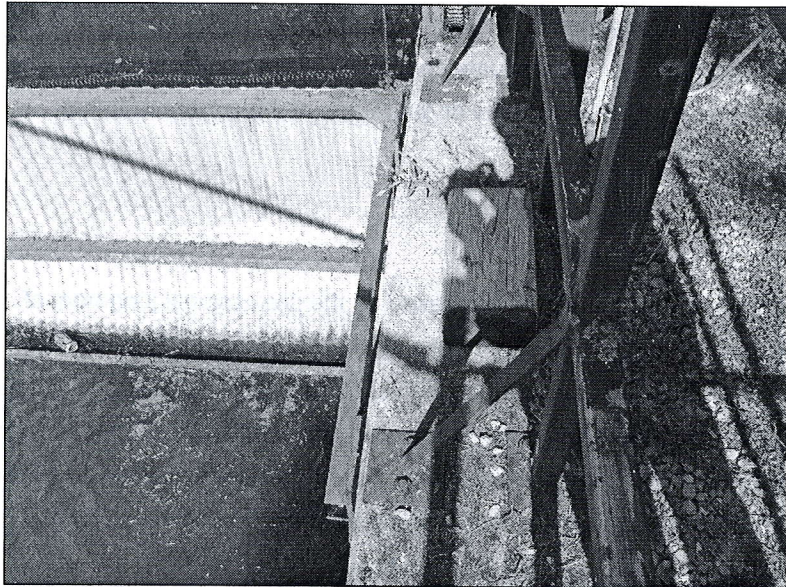
10040930201513

Bottom gate seal leak
